CASE STUDY 0100

Plastics Manufacturer Achieved a 944% ROI in 30 Days.

The Strainrite Companies faced significant production issues due to faulty third-party sonotrode essential to the production of filtration products.

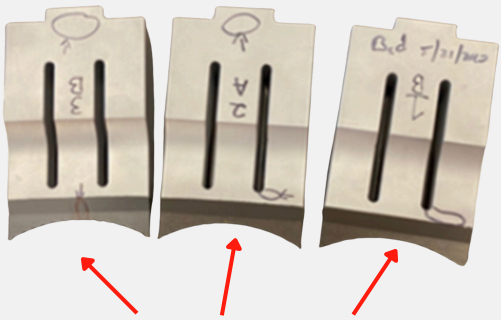
Defective Sonotrodes

Strainrite's existing sonotrodes were prone to cracking every 9-11 months at the points indicated.

- Every nine to eleven months the sonotrode would crack at the top and face of the sonotrode.
- Even a small defect in the sonotrode made the tool unusable. Because the tool could no longer vibrate, it halted the production of filters.
- The cost of replacing the sonotrodes became a significant expense.

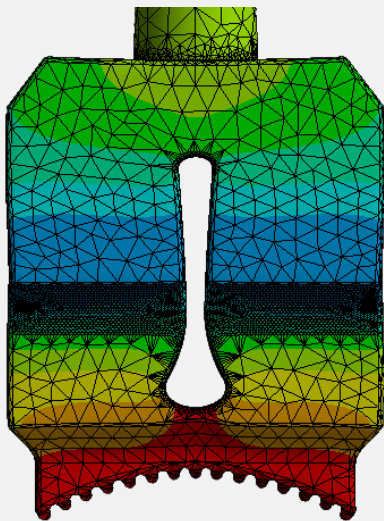
The novel tear drop sonotrode design

The FEA analysis of the teardrop sonotrode design shows the stress points evenly distributed evenly to prevent cracking. Herrmann Ultrasonics created a novel tear-drop shaped sonotrode for uniform distribution of amplitude.

To address these issues, Herrmann Ultrasonics introduced a novel tear-drop design for the new and improved sonotrode. This new design featured a more uniform distribution of amplitude on the face, as depicted in the FEA analysis image, which showed improved performance characteristics.
